# Kings Arms 2013

## Prior to any works being undertaken

Most of these photographs were taken on 3rd December 2013.

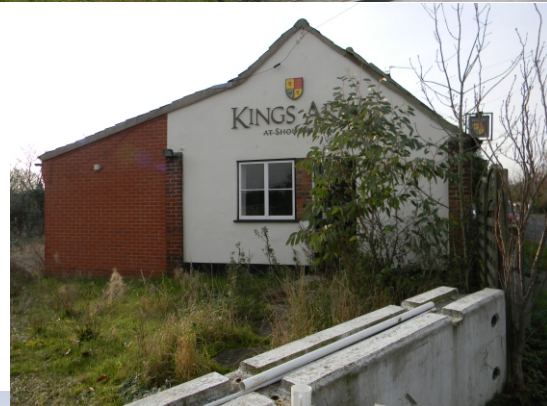
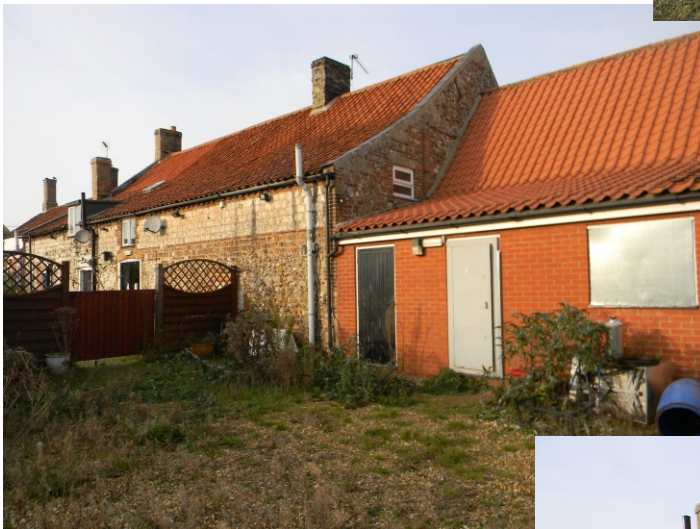
The side to the rear car park shows the kitchen extension. The rear photographs show some of the different building materials that have been used. Note the uPVC window in the end wall, lighting up the bathroom. There are a number of in filled windows in the rear elevation.

The kitchen extension was built c2005 and is of entirely different construction.

From the side the "barn", former post office roof looks as though it has been modified.

The whole rear appears to be an

extension from the original property. Where the roof angle changes it matches a thick internal wall location.

A fireplace within the main building extension (to the left) gable wall no longer has a visible chimney stack.

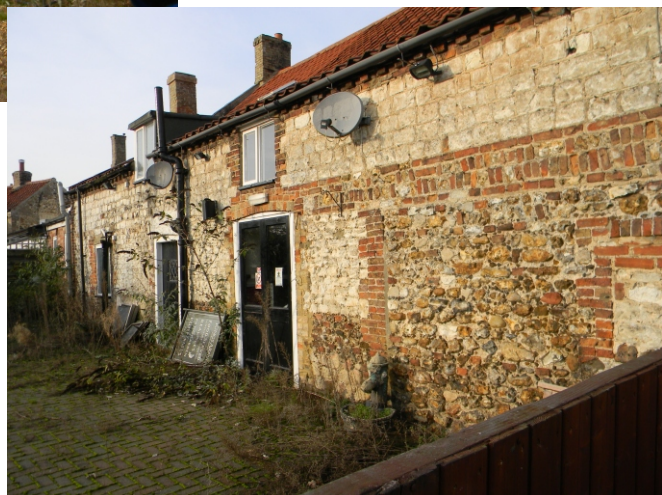
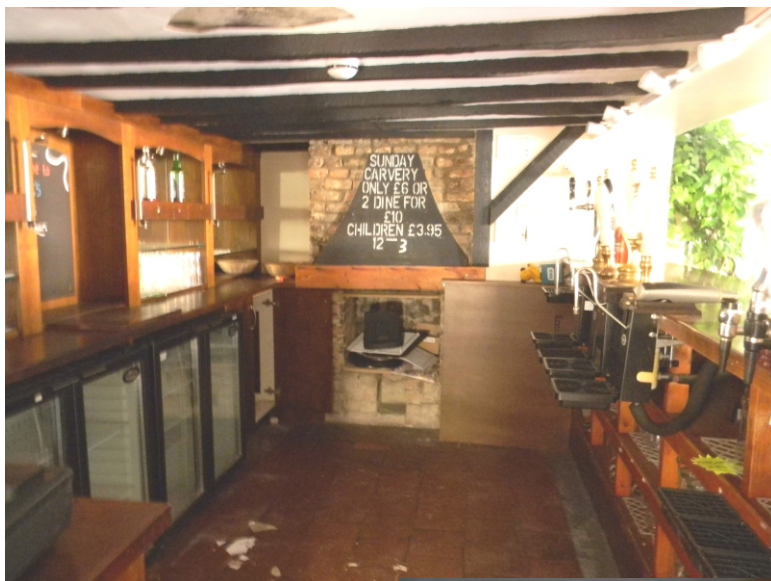
The current bar area has a very low ceiling, (about 1.7m), retains a small fireplace whilst from the outside a door in the buildings rear wall is masked by the bar fittings(?).

The floor to the bar area is lowered about 6 inches from the customer area.

The entrance to the existing toilets is up a step and through a narrow doorway. Adjacent to this door is a fireplace with a

double door log burner (multi-fuel?) which appears to have a lined chimney.

A wide but steep staircase leads from the front door entrance on the Green to the first floor accommodation and divides the bar area in two.

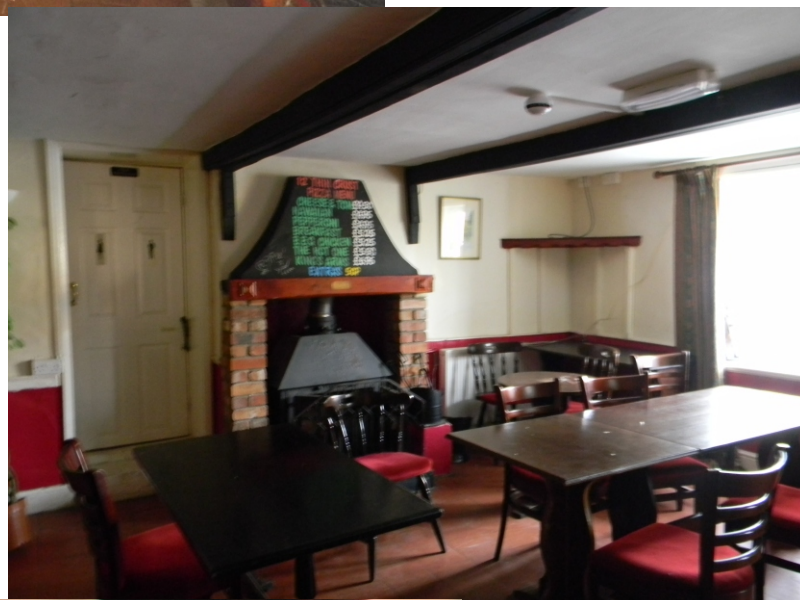
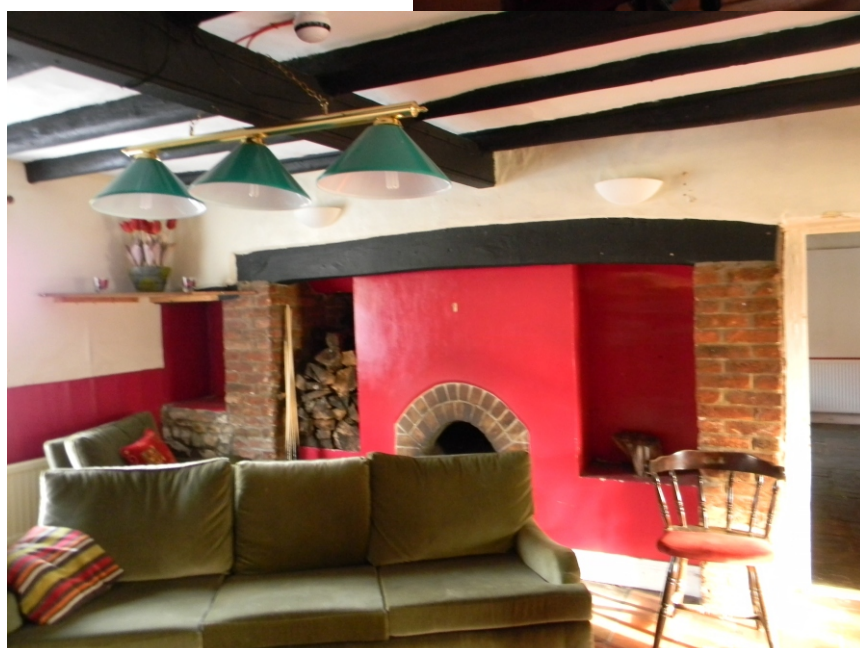
Turning around the second space has a large fireplace

which has been partially bricked up and a small fire grate left in its centre.

It appears smoke detectors and emergency lighting is fitted, the control panel for which is located in the bar area. However the snooker table lights were fitted by the last tenant.

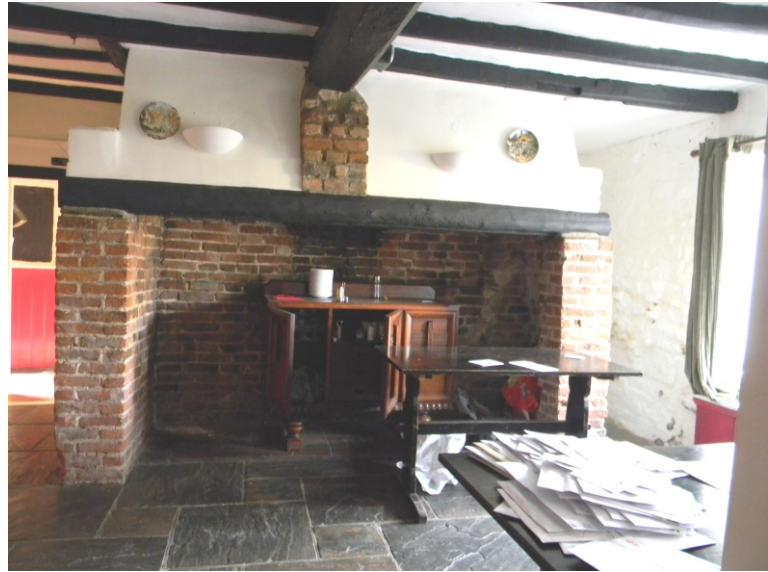
A low height corridor leads to the third room where is the other half of the main chimney stack. This chimney stack has a second fireplace which is like an inglenook being higher inside than the recently fitted mantel which is an RSJ with a telegraph pole insert. There is a door onto the Green in this room through which mail is delivered.

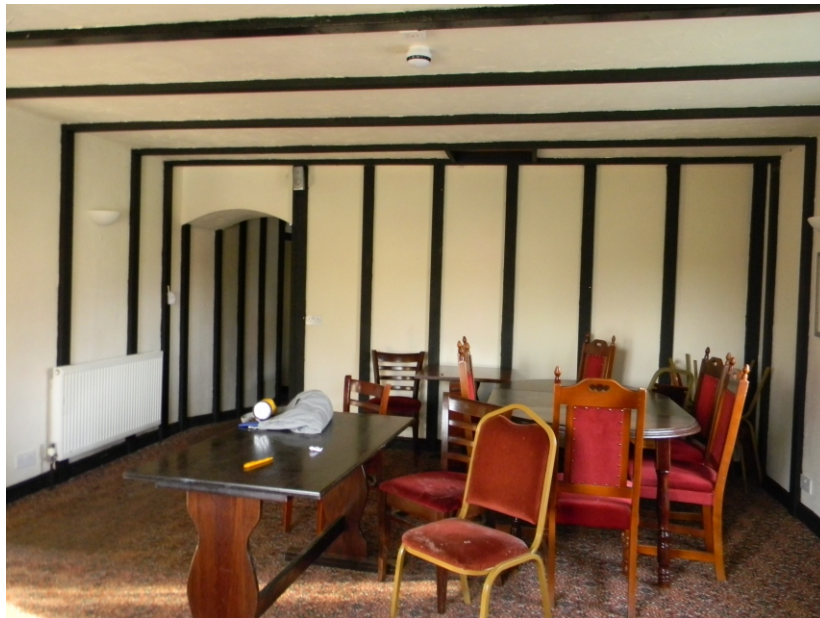
There is a slope down and small step into the fourth space.

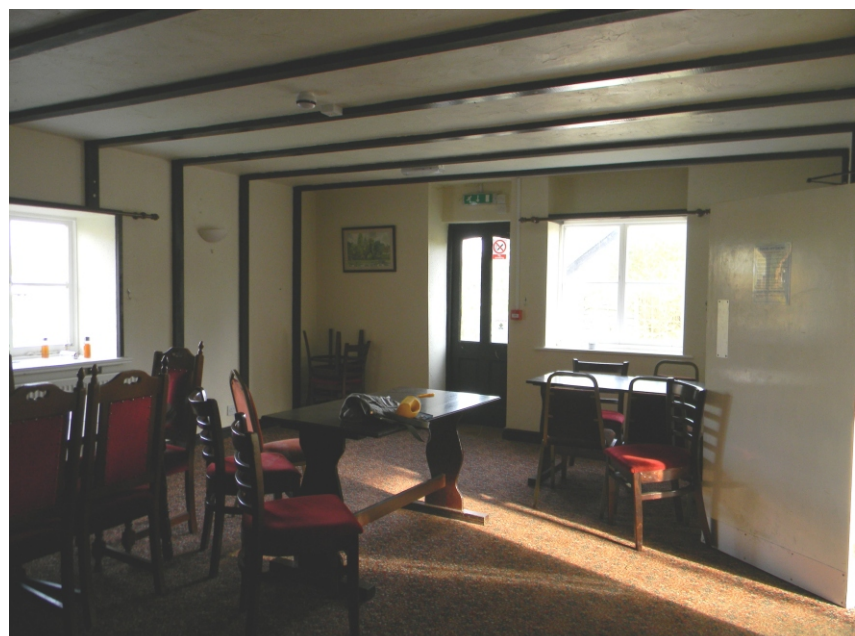
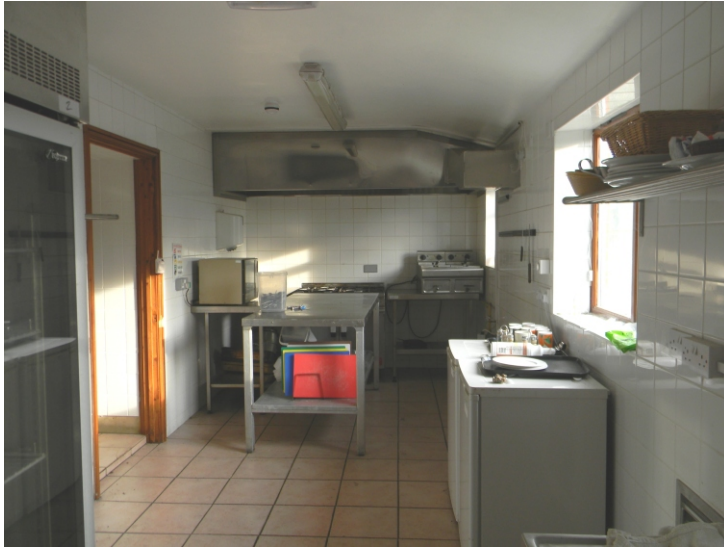
A further doorway slopes upwards into the fifth and last room which was a converted barn used as a post office during the 1990's.

This area has been carpetted unlike rooms 1,2 and 3. There is a door into the kitchen with a small step down and a narrow door to the outside.

The kitchen was fitted c2005 with stainless steel furniture. It is known a push-through commercial dishwasher was once installed but has been removed, now a double deep sink unit exists here with a small hand washing bowl in the adjacent freezer area.

There is a large doubled fronted glass chiller unit, two under counter refrigerators, an old commercial microwave, a single

large oven 6 burner cooker and a double fat fryer in the kitchen area. There is some doubt about the legality of the extractor fan fitting above the oven.

The oven is LPG gas fired. The two large gas tanks are outside.

A small adjacent room is occupied by a sink, and old washing machine and a large chest freezer.
